AFRL-ML-WP-TR-2004-4196

**ENDURANCE PUMP TEST WITH MIL-PRF-83282 HYDRAULIC FLUID,
PURIFIED WITH MALABAR
PURIFIER**

JUNE 2004

Interim Report for 01 January 2002 – 01 June 2004

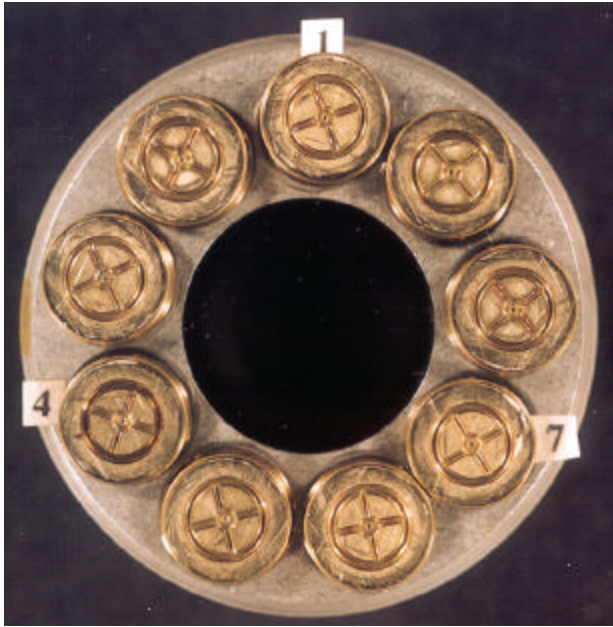
Piston Shoe Faces at Pretest
Purified Fluid

- f) The drive shaft inner splines appear as good as pre-test condition and the drive shaft bearing and carbon seal appear virtually new.
- g) The shoes are very clean, showing no cavitation damage and appear more or less new. Very mild polishing on the outer shoe perimeter is almost indiscernible from new. Each shoe was dimensioned for ball joint endplay and shoe flange thickness.

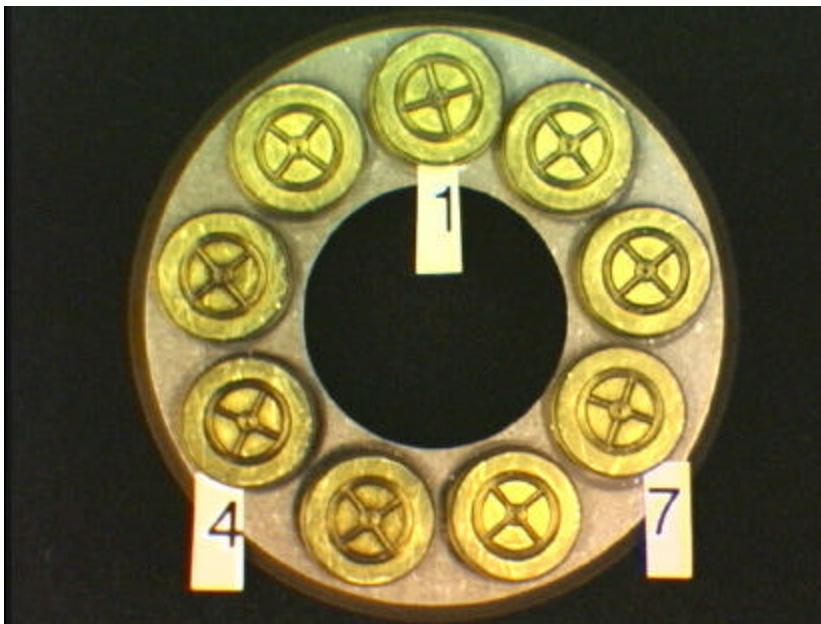
Piston Shoe Faces at 1500 Hours
Purified Fluid

- a) The shoes are very clean, showing no cavitation damage and appear more or less new. Very mild polishing over the face of each shoe is almost indiscernible from new. Each shoe was dimensioned for ball joint endplay and shoe flange thickness. The dimensional differences for shoe flange thickness have stopped decreasing measurably.

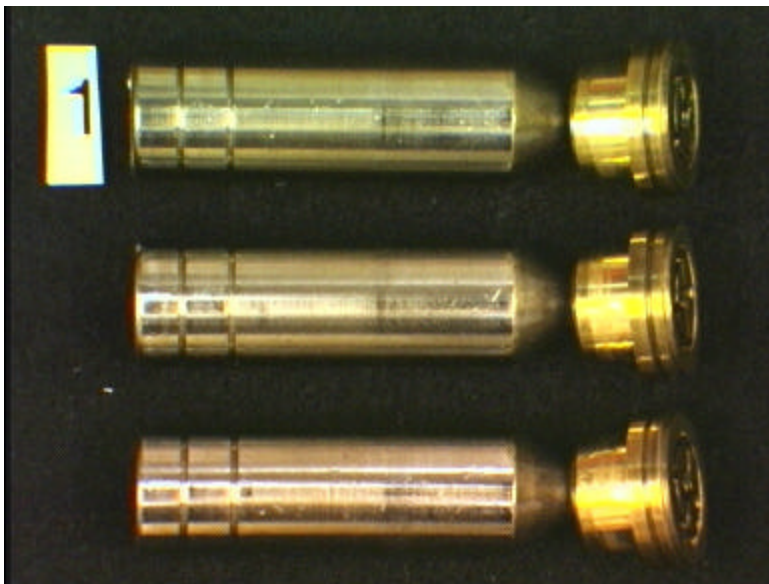
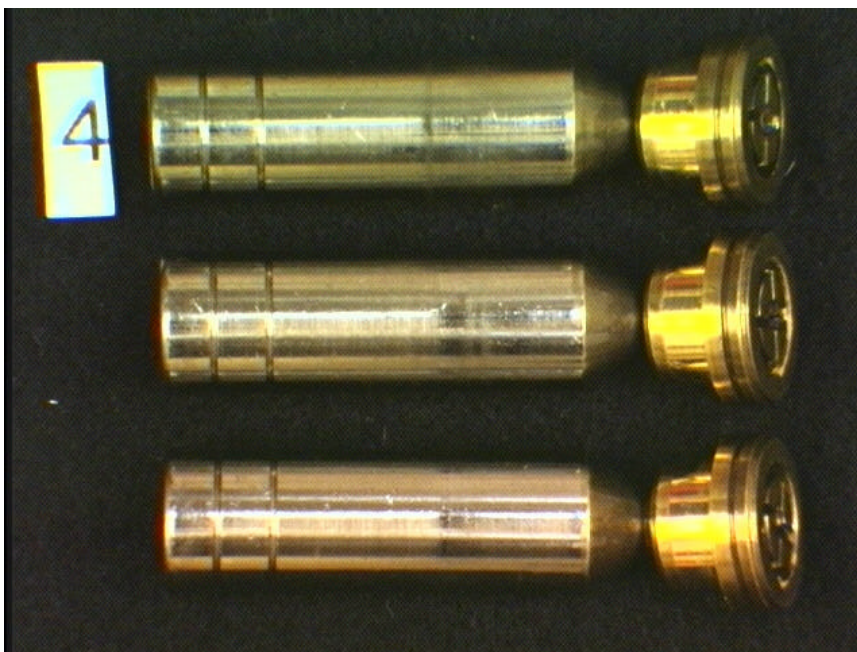
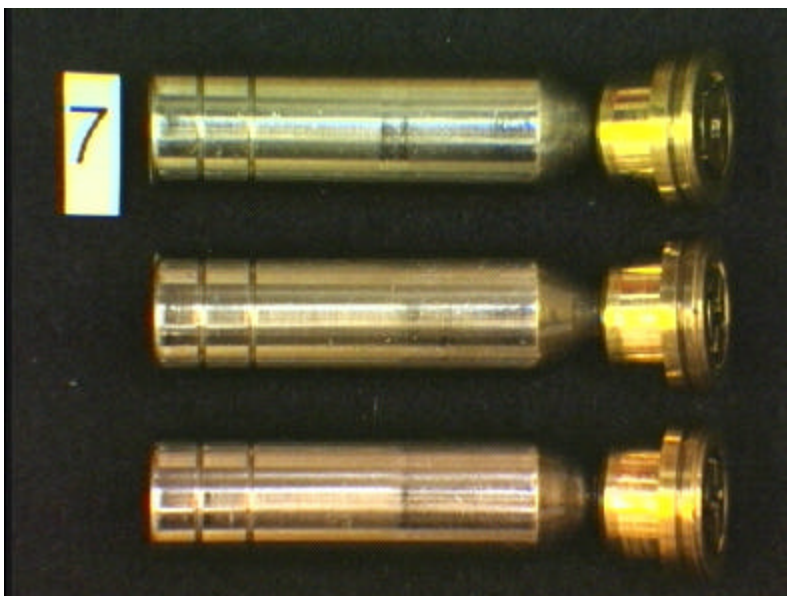
- b) The pistons show a small increase in polishing, banded in the lower half of the length. The hold down plate retainer has typical rotation striations from the piston shoe retaining plate, virtually unchanged from the last inspection. The mild tarnish on this same side was observed to be essentially identical as before.

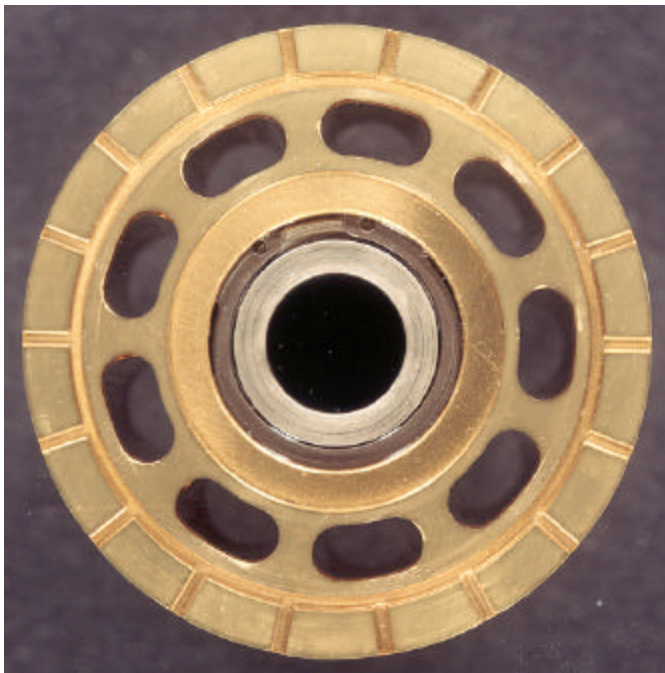
Cylinder Block Face at 1515 Hours
Fresh Fluid

- a) The mild cavitation erosion located on the outer trailing edge of the cylinder block kidney ports has not increased since last inspection.
- b) The shoes are very clean, showing no cavitation damage and appear close to new, except for polished axial fretting marks on the outside periphery of the gimbal ball joint sockets. The original tooling pattern is still visible on the shoe faces. Very gentle polishing on the outer shoe perimeter is almost indiscernible from new. Each shoe was dimensioned for ball joint endplay and shoe flange thickness, showing typical change in dimensions listed below.

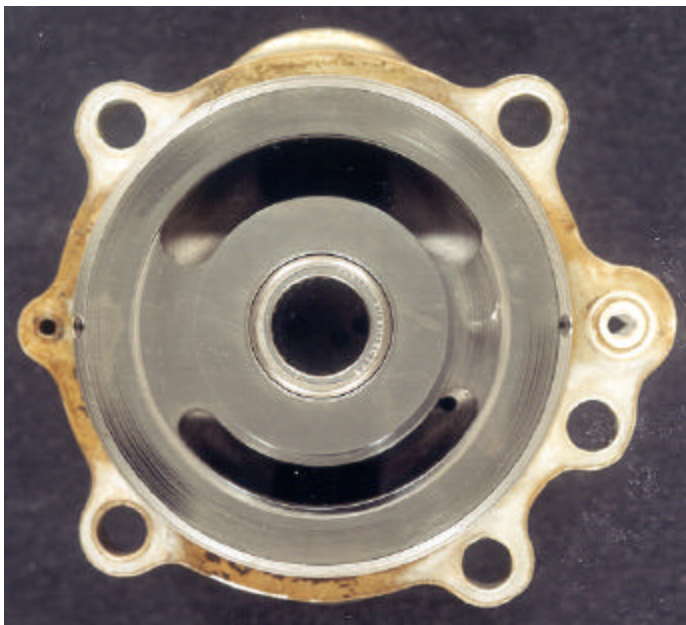
Valve Plate at 1515 Hours
Fresh Fluid

- e) No change in the valve plate surface occurred. This surface appears almost new except for the same shallow irregular cavitation pit noted before, which showed no additional growth, found roughly midway between the inlet and outlet ports on the piston recharging side.

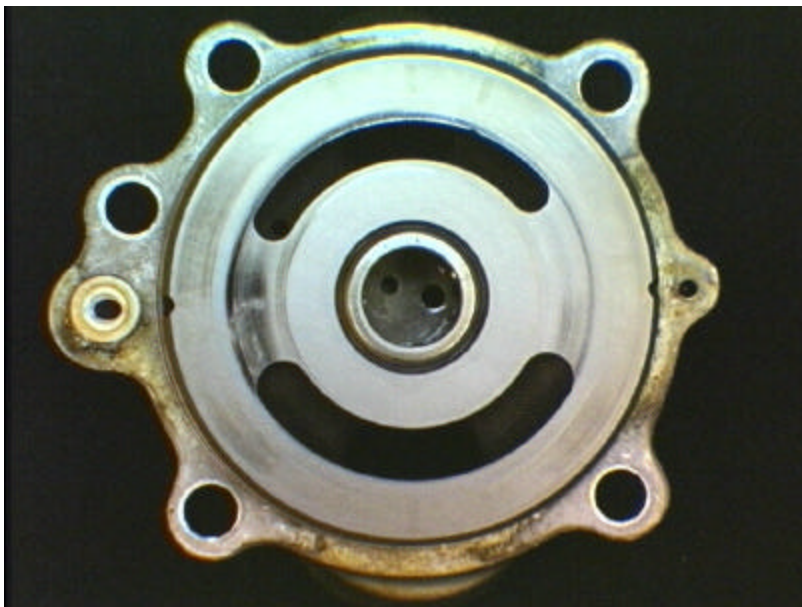
Valve Plate at 1500 Hours
Purified Fluid

- c) No appreciable wear on the inner race of the valve plate bearing is evident.
- d) The valve plate surface still appears almost new, except for the small cavitation pit and earlier formed shallow irregular cavitation pit, which have hardly changed.

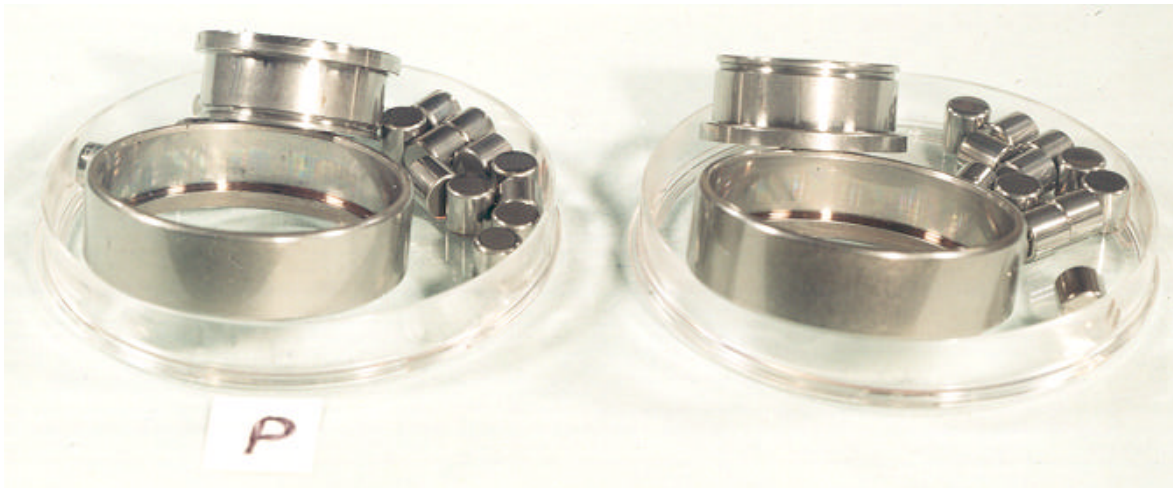
- h) Both yoke trunion bearings have excellent rolling surfaces; but the rollers in the bearing closest to the case drain port still display the crescent profile polish marks (unchanged), found on the edges of both sides of those rollers.
- i) The actuator piston's minute circular polishing mark in the extreme center of the contact surface has started to broaden, overall much less wear than in previous tests at this interval.
- j) The torque coupler mating splines on the external coupling shaft do not show any difference in the existing fretting.

Yoke Pintle Bearings at 1515 Hours
Fresh Fluid
[white square denotes case drain outlet side]
